PERFORMANCE TEST REPORT

SPRAY POLYURETHANE FOAM ALLIANCE

PROJECT: Racking Load Tests

Report No.: 67937.01-120-32
Test Dates: 02/06/07
And: 02/07/07
Report Date: 02/12/07
Report Retention Date: 02/07/11

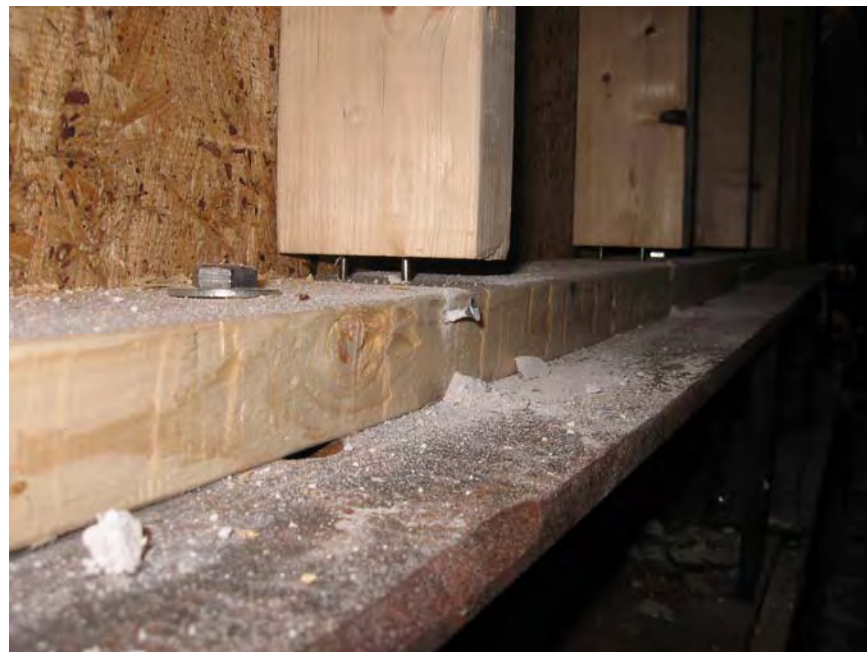
Specimen	Ultimate Load (lb)	Comments	Photo No.
1	2,908	At 2,908 lbs. the panel would no longer hold a load. The nails through the sill plate began to pull out of the vertical studs.	2
2	1,109	At 1,109 lbs. the panel would no longer hold a load. The drywall had cracked and the screws had pulled through. The nails through the sill plate were beginning to disengage from the vertical studs.	3
3	2,259	At 2,259 lbs. the panel would no longer hold a load. The nails through the sill plate were bent and disengaging from the vertical studs.	4
4	2,152	At 2,152 lbs. the panel would no longer hold a load. The nails through the sill plate were bent and disengaging from the vertical studs.	5
See Chart No. 1 though 4 in Appendix A.

Photo No. 2
Sample #1 Stud Disengagement

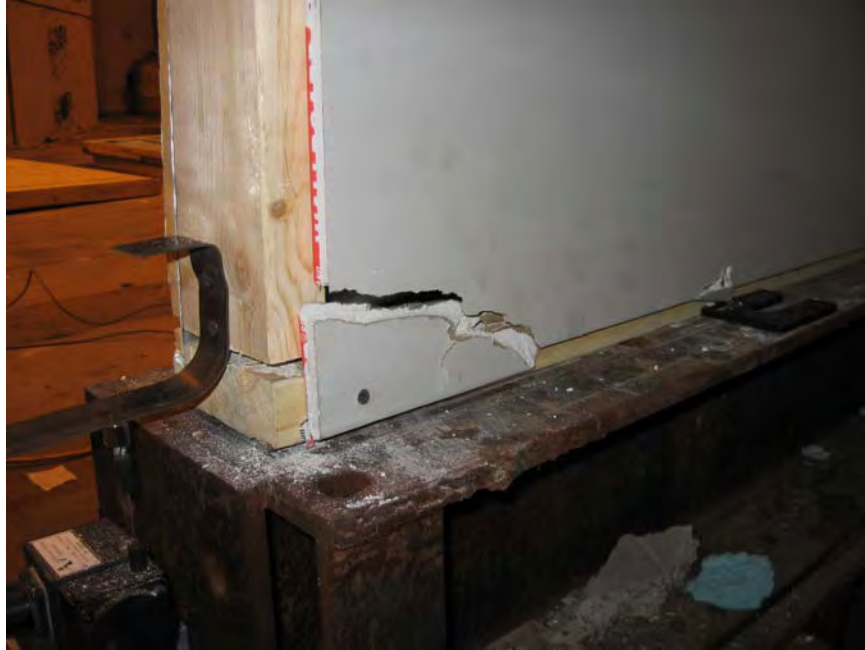
Photo No. 3
Sample #2 Stud Disengagement and Drywall Cracking

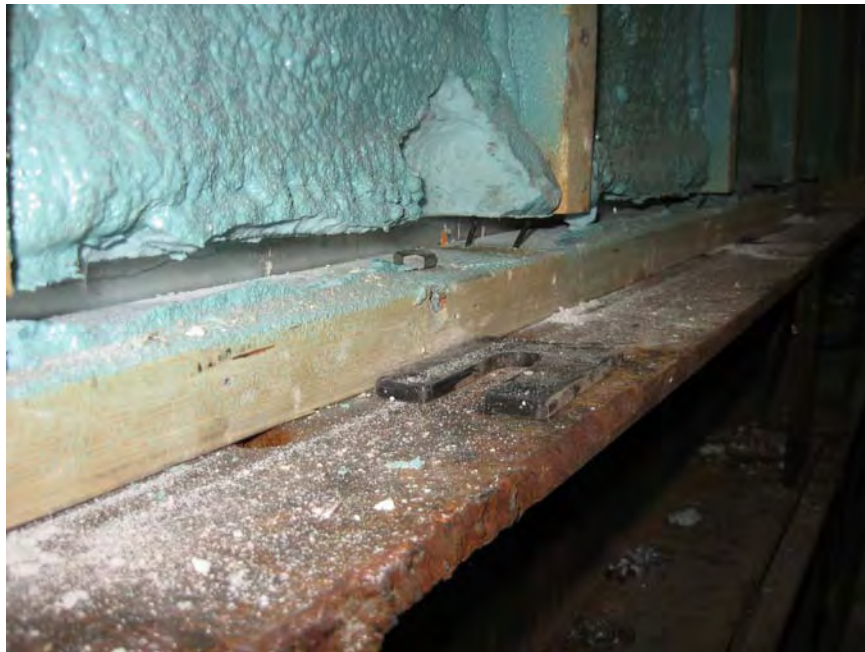
Photo No. 4
Sample #3 Stud Disengagement

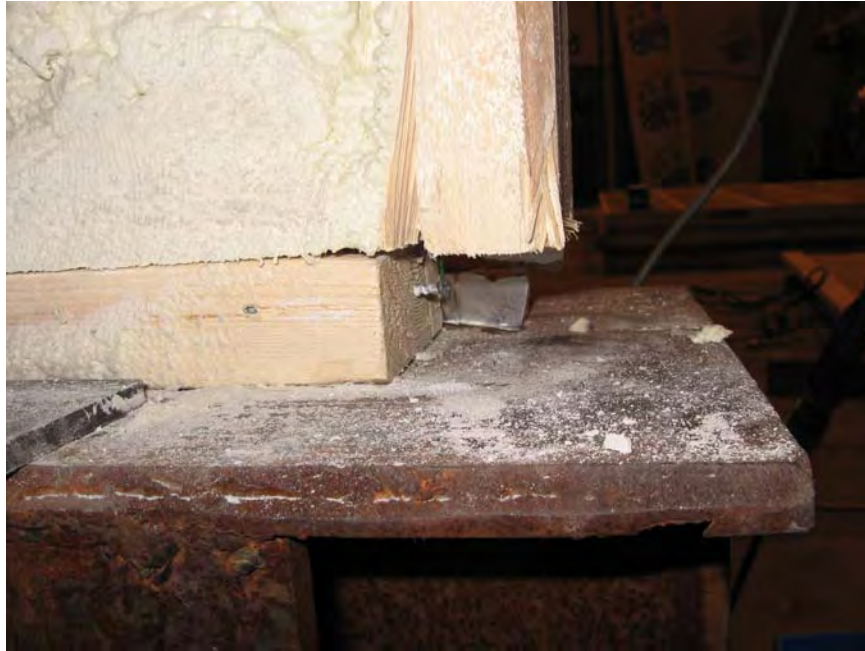
Photo No. 5
Sample #4 Stud Disengagement
