CLOSED-CELL SPRAY FOAM

Resisting Wind Uplift in Residential Buildings

RICHARD S. DUNCAN, Ph.D., P.E.

JINHUANG WU, Ph.D.

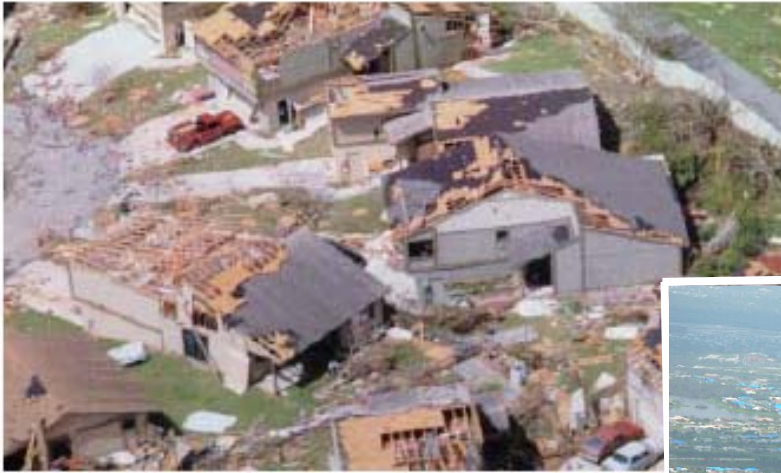
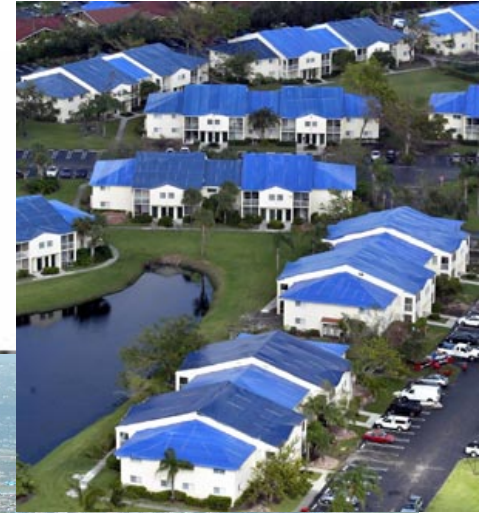
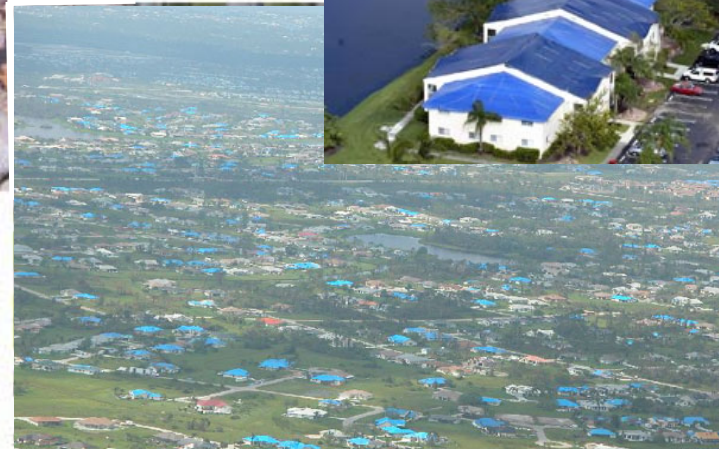
Roof deck failures are the leading cause of residential building loss

Houses with damaged or missing roof sheathing in Florida

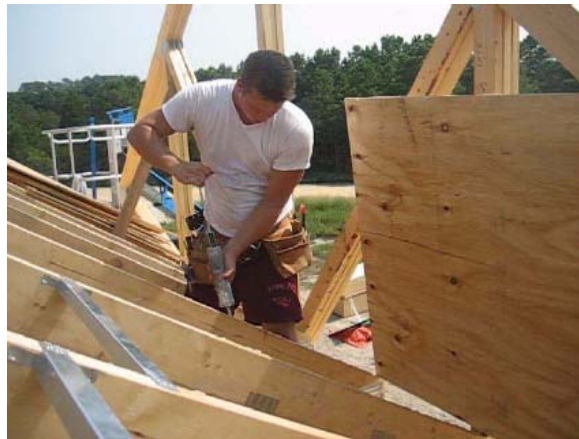
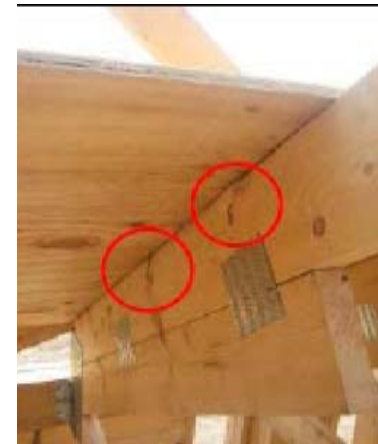
- Older nailing schedules used for deck attachment
- Real-world nailing doesn't match code
- Over-driven fasteners
- Nail misses

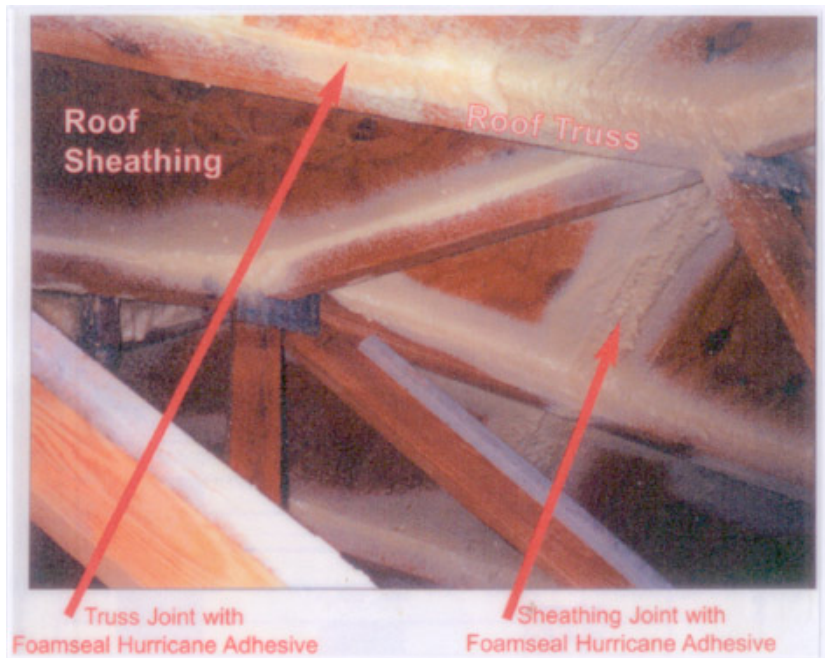
When applied between deck and framing members, ITW™ Foamseal® SF2100 Hurricane Adhesive System can provide significant wind uplift resistance in Category IV or V conditions

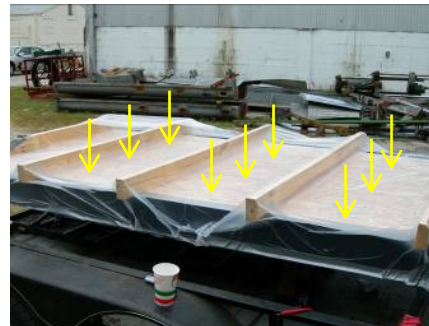
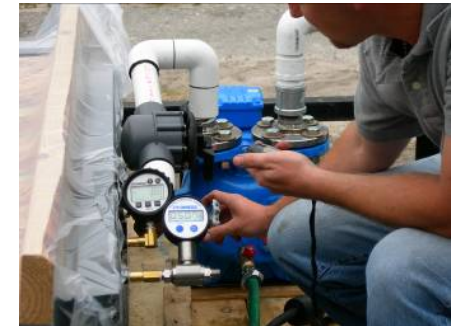
MODIFIED ASTM E330 TEST PROCEDURE

1. Attach 2x4x5' members across width of sheathing
2. Place specimen in a 4.5' x 8.5' vacuum box so that sheathing is face-down and 2x4s straddle the box
3. Seal with 2 mil PE film for Single direction loading
4. Draw vacuum inside box applying pressure to inside surface of the specimen (15 psf increment, 10 second hold)
5. Record pressure at failure

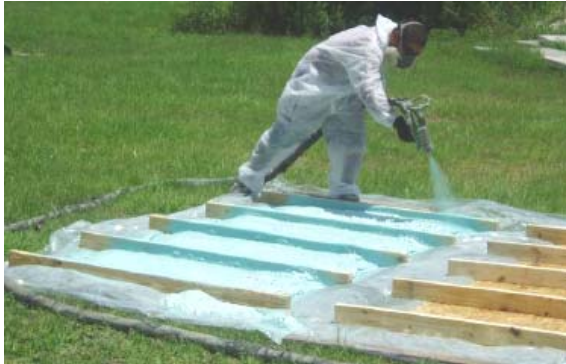
SPECIMEN PREPARATION

- NCFI Polyurethanes InsulStar® 2lb foam applied by Xtreme Foam
- 15 specimens produced in total
- Fastener type: 6d common
- 6" spacing ends and 12" spacing in field (pre 2001 nail schedule)

NCFI InsulStar® foam (applied by Xtreme Foam – Orlando, FL)

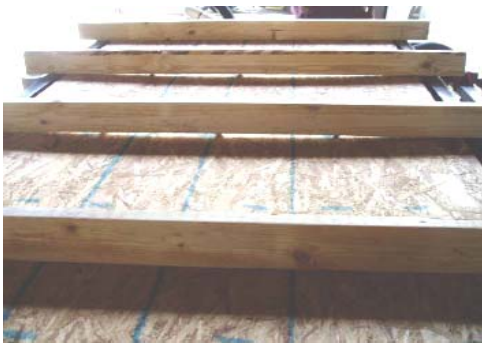
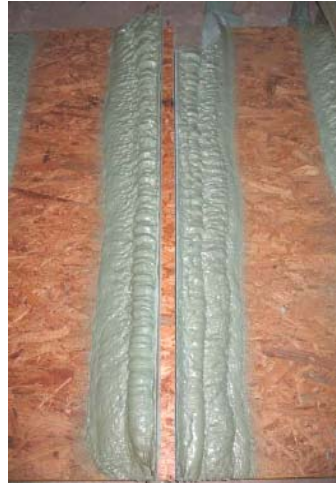
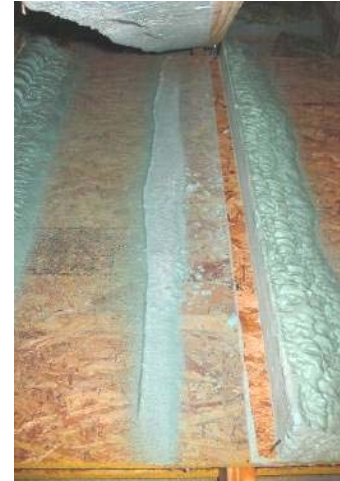
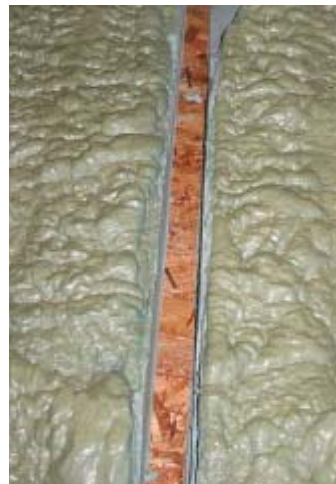
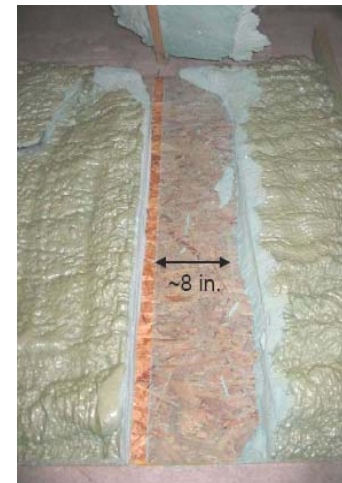
- Failure modes can vary
