PERFORMANCE TEST REPORT

SPRAY POLYURETHANE FOAM ALLIANCE

PROJECT: Racking Load Tests

Report No.: 67937.01-120-32
Test Dates: 02/06/07
And: 02/07/07
Report Date: 02/12/07
Report Retention Date: 02/07/11

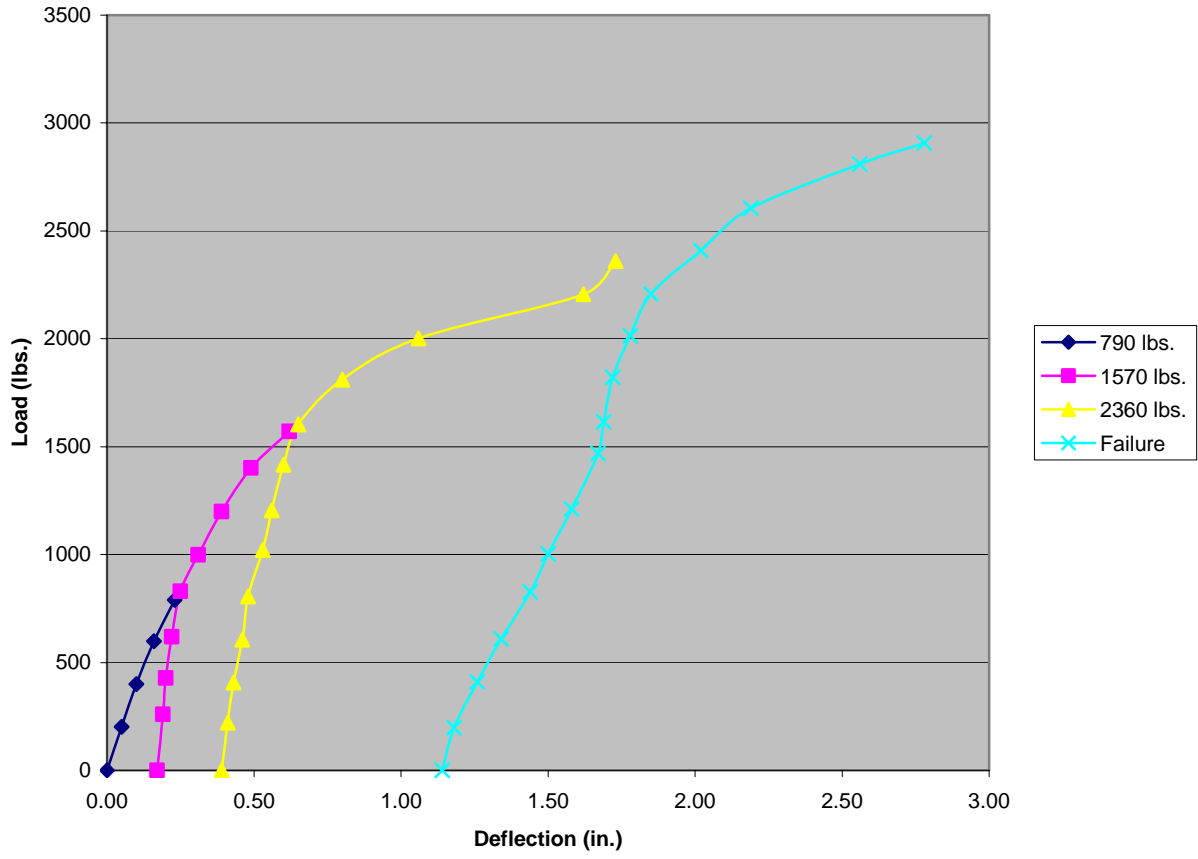
Sample #1

Specimen	Ultimate Load (lb)	Comments	Photo No.
1	2,908	At 2,908 lbs. the panel would no longer hold a load. The nails through the sill plate began to pull out of the vertical studs.	2
2	1,109	At 1,109 lbs. the panel would no longer hold a load. The drywall had cracked and the screws had pulled through. The nails through the sill plate were beginning to disengage from the vertical studs.	3
3	2,259	At 2,259 lbs. the panel would no longer hold a load. The nails through the sill plate were bent and disengaging from the vertical studs.	4
4	2,152	At 2,152 lbs. the panel would no longer hold a load. The nails through the sill plate were bent and disengaging from the vertical studs.	5
See Chart No. 1 though 4 in Appendix A.
