SPRAY FOAM Insulation and Subterranean Termites in Basements and Crawlspace

Spray Foam Insulation & Subterranean Termites

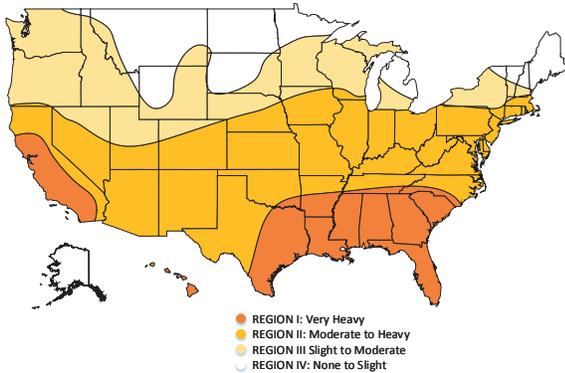
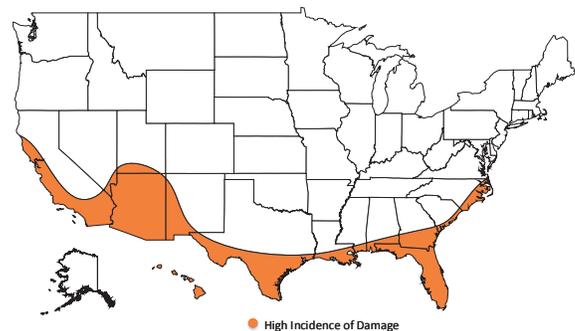
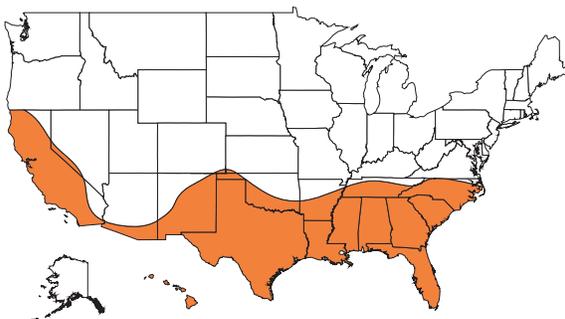
FIGURE 2. Probability of Subterranean Termite Infestation for the US

Native Subterranean Termites – The most common type of termite. Colonies typically live underground to maintain moisture levels in the colony, though colonies can survive without ground contact if moisture levels are sufficient. They construct protective shelter tubes (or mud tunnels) from the soil to food sources in a building.

Drywood Termites – These termites are not subterranean, but create colonies in structural lumber with no connection to the ground. These termites need little water to survive. Infestations, often found in attics, typically identified by frass pellets.

Formosan Termites – A type of subterranean termite that build nests within the soil. They can also create carton nests in structures that retain moisture, thus no longer needing contact with the ground.

Termites voraciously consume cellulose, meaning that any plant-based material can be a source of food – including leaves, compost, wood piles, cardboard, paper, and of greatest concern, wood components and furnishings of a home. While there are many (45-50) species of termites in the US, only about five are known to be serious pests of structures.ⁱ Figure 2 shows the probability of termite infestation (by type) across the entire US.ⁱⁱ

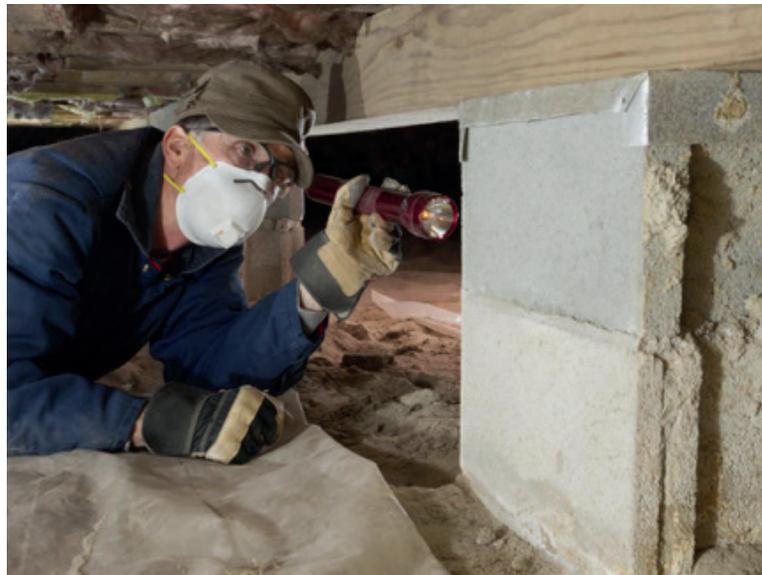
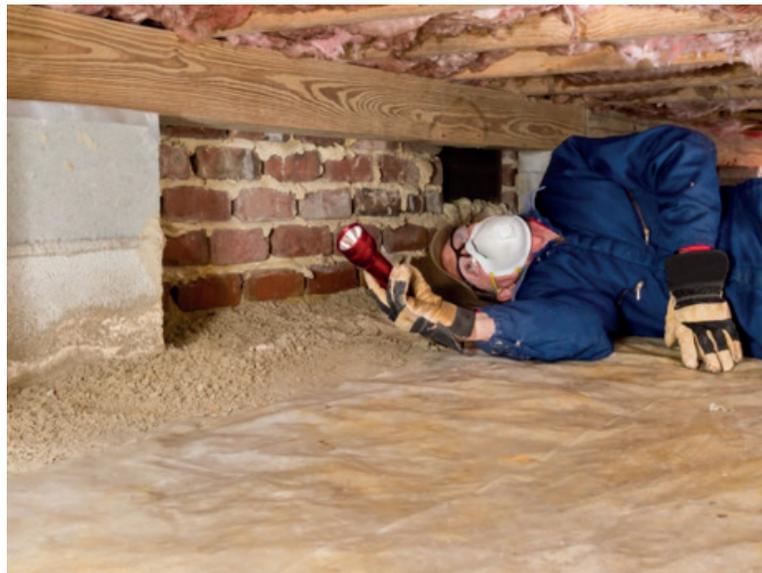
FIGURE 3. Visual termite inspection

Trained professionals inspect accessible areas where termite infestation is likely to occur, looking for visual signs or wood damage. Termite inspectors typically look for shelter tubes from subterranean termites that serve as protected pathways between the underground colony and their food source. Examples of shelter tubes are shown in Figure 4. Inspectors look for evidence of termites in parts of the structure that contact or are near the foundation (sill plates, band/rim joists and floor joists). An example of termite damage are shown in Figure 5.

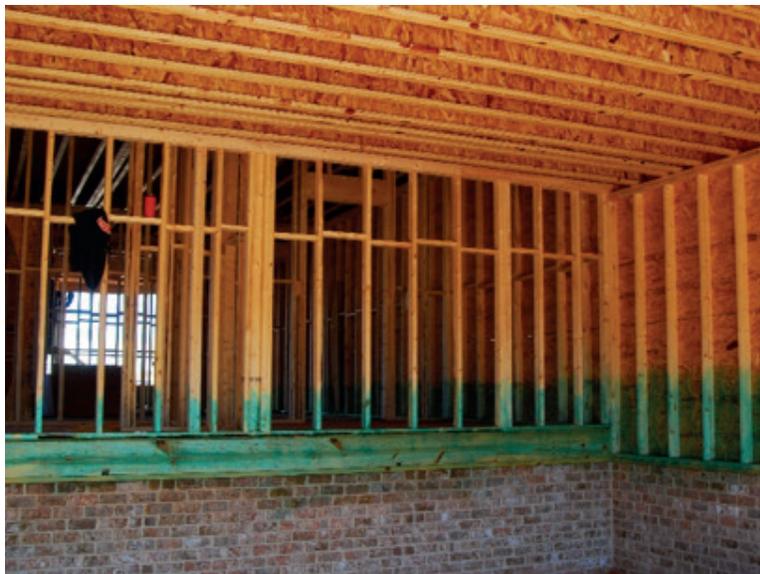
FIGURE 6. Borate treatment of select structural wood components

- Borate treatment of select wood members (Figure 6)
- Termiticide application to soil under slabs, at potential termite entry points and adjacent to foundation walls (Figure 7)
- Termite baiting systems (Figure 8)
- Use of preservative treated wood or termite resistant wood (Figure 9)*
- Physical barriers beneath slabs and at termite entry points (Figure 10)
- In areas of very heavy termite infestation:
 - o The use of foam plastic insulation is *not permitted* on the exterior face of walls, or below footings, foundations or slabs that are below grade.
 - o Foam plastic on above grade walls must be 6" above the ground.

Examples of pre-construction termite control are shown in Figures 6-10. The baiting system and termiticide treatment of the soil near the foundation may also be used in existing construction. It should be noted that the IRC and IBC are model building codes, which may be adopted in full, in part, or modified by state, county, and municipal authorities. Certain buildings may have different requirements for termite control. For example, FHA and HUD do not recognize treated wood adjacent to the foundation. There are differences between termite shields and barriers. Shields, including sheet metal, do not always provide a continuous termite barrier, but can help with detection.

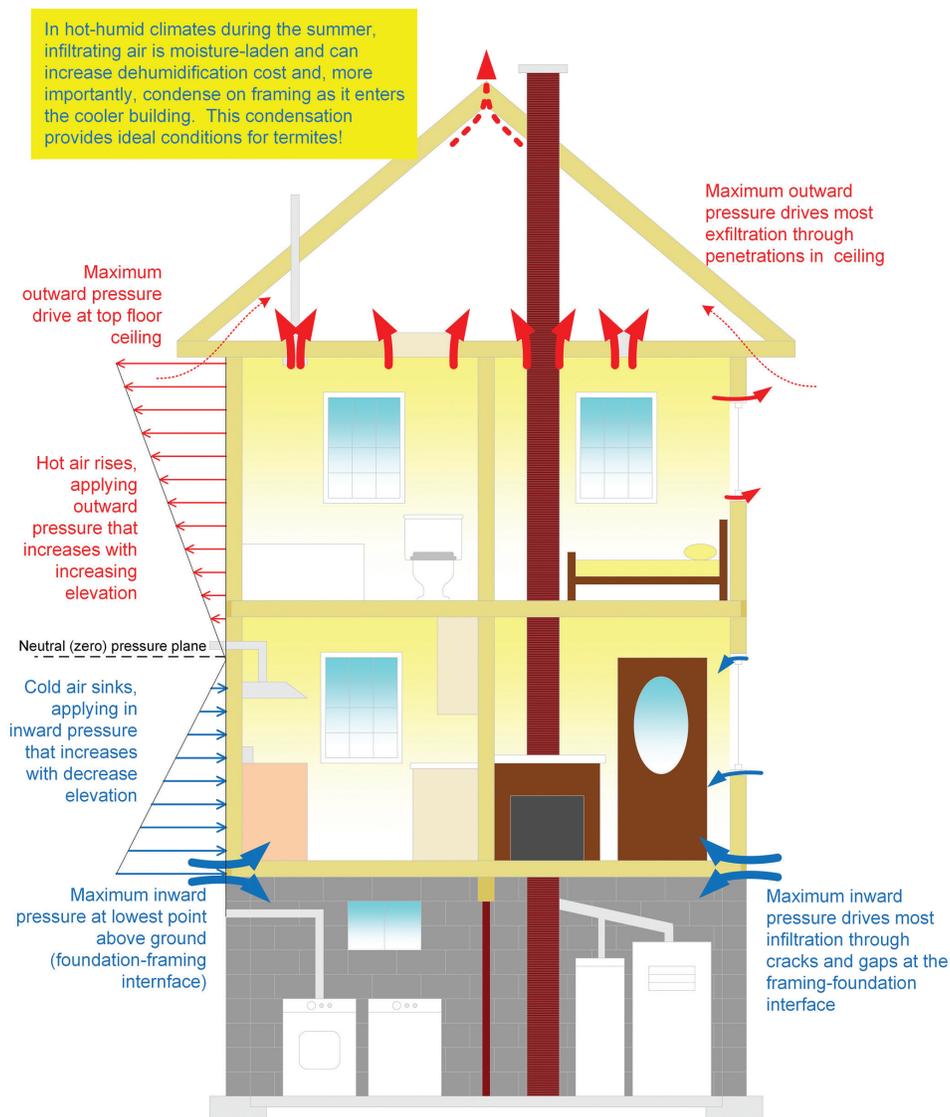
FIGURE 11. Stack effect and air infiltration paths near the building foundation

Recent changes to many model energy codes now call for buildings with increased levels of insulation and significantly reduced air leakage. One of the most significant sources of air leakage in framed buildings occurs where the framing meets the foundation, as shown in Figure 11.

Driven by differential pressure, air infiltration occurs through gaps between the sill plate and foundation, at the bottom and top edges of the rim joists, and through various penetrations for plumbing, wiring and ductwork. In homes built more than about 10-15 years ago, these areas were rarely insulated and almost never properly sealed compared to today's practices.

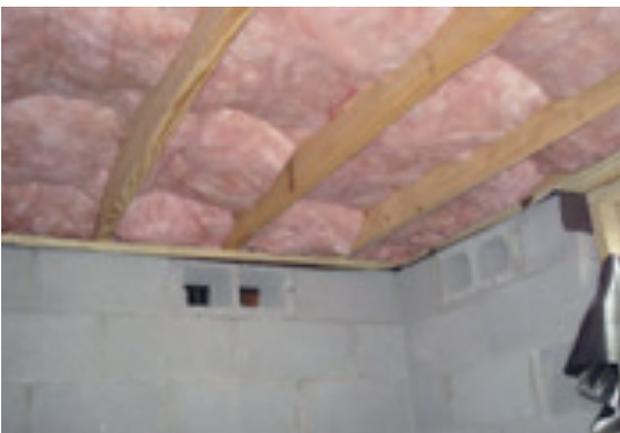
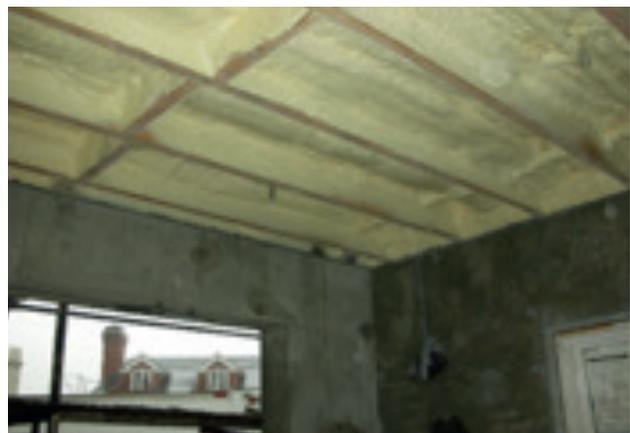
FIGURE 12. Under floor insulation examples showing fiberglass batts in a vented crawlspace (left) and closed-cell SPF in an unconditioned basement (right).

Insulation of the floors includes application of insulation to the underside of the subfloor, in contact with the band/rim joists. This is an important target area warranting effective moisture and energy control strategies utilizing advanced materials such as spray foam to resist air infiltration from the 'stack effect'. Using closed-cell SPF helps to avoid condensation within the subfloor materials and minimize air infiltration into the rooms above.

In these under-floor applications, use of a Class 1 vapor retarder (commonly 0.1 perm or less) has been installed below the concrete slab in these basements, or over the gravel/sand on crawlspace floor. Typically, this vapor barrier is a polyethylene membrane that is 6 mils or greater in thickness. Use of this vapor barrier helps to reduce moisture levels in these unconditioned basements and vented crawlspaces.

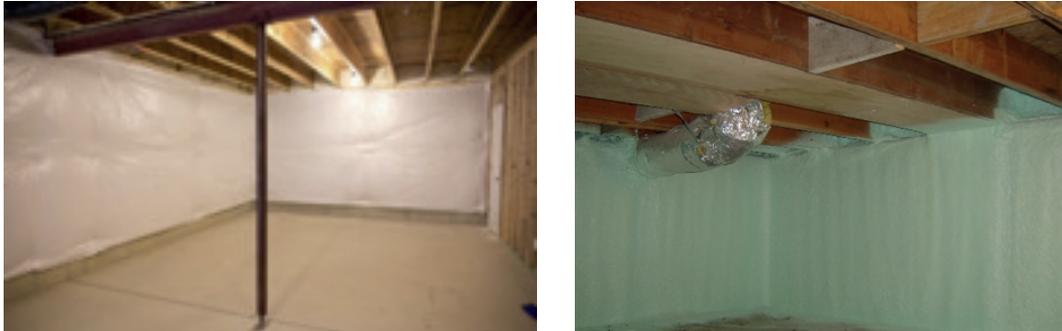
FIGURE 13. Below-grade wall insulation examples in a conditioned basement (left) and closed-cell SPF in an unvented crawlspace (right).

Insulation of the walls in conditioned basements and unvented crawlspaces includes application of insulation from the subfloor to the basement/crawlspace floor. Using closed-cell SPF can help to avoid moisture movement and damage to the insulation in the event of flooding. Closed-cell SPF is the only cavity insulation approved by FEMA as a flood damage-resistant material.⁵

In these wall applications, use of a Class 1 vapor retarder (commonly 0.1 perm or less) has been installed below the concrete slab in these basements, or over the gravel/sand on crawlspace floor. Typically, this vapor barrier is a polyethylene membrane that is 6 mils or greater in thickness. Use of this vapor barrier helps to reduce moisture levels in these conditioned basements and unvented crawlspaces.

The first method often used by builders of new homes and weatherization contractors in existing homes is the application of SPF at the framing-foundation area. This method is often regarded as an especially reliable method to provide long-lasting insulation, air sealing and moisture control for these critical areas with a single product; however, this method may impair simple visual inspection of the sill plate, rim joist or ends of floor joists (Figure 13, & Table 1).

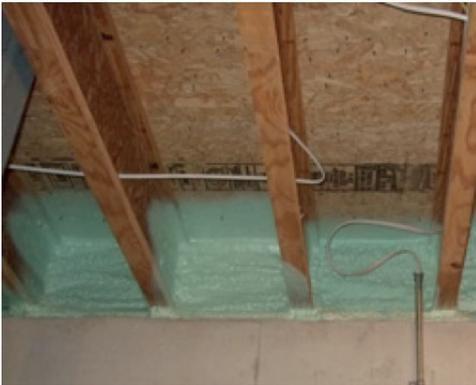
Spray Polyurethane Foam

SPF covers and seals cracks and gaps along walls parallel and perpendicular to floor joists.

SPF provides high R/inch insulation and air seal on cracks, gaps and penetrations.

SPF provides an integral Class II vapor retarder at thicknesses greater than 2".

SPF is not easily removable and encapsulates the band/rim joist and sill plate, possibly impairing simple visual inspection for termites, if unaided by advanced detection equipment.

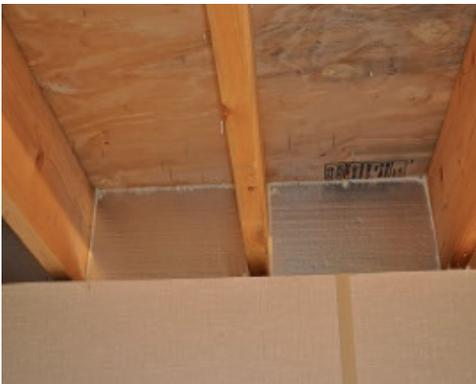
Foam Board with Caulk/Sealant

Requires precision cutting and installation of caulk and sealant in tight spaces.

Foam board and caulk/sealant insulates and air seals gaps except that between the sill plate and top of foundation.

Most foam board insulations provide an integral Class II vapor retarder. Check water vapor resistance of unfaced foams.

Sealed foam board is not easily removable and encapsulates the band/rim joist possibly impairing simple visual inspection of the band joist, but does allow inspection of the front of the sill plate.

The use of cut foam insulation board sealed along its perimeter with caulk or polyurethane foam sealant is the second method. It is generally more labor intensive than SPF application, as it requires cutting of the foam board followed by the application of a caulk or sealant. It can be an especially difficult application in tight areas and will require extra cutting to fit around engineered wood I-joists. Like SPF, this application provides long-lasting insulation, air sealing and moisture control. Note that this method, unlike SPF, does not always provide sealing of the gap between the sill plate and foundation and may impair access for simple visual inspection (Table 1).

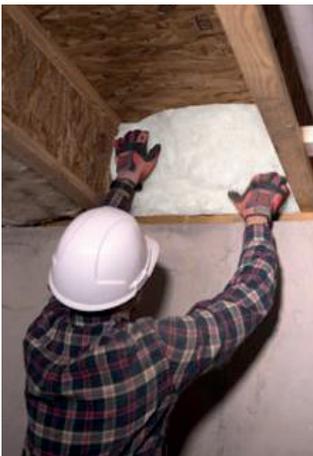
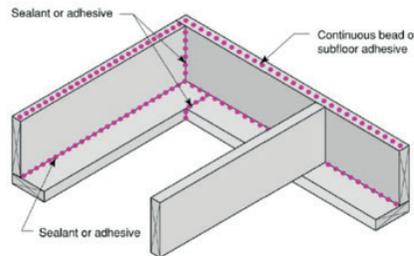
Fiberglass with Caulk/Sealant

Requires precision cutting and installation of caulk and sealant in tight spaces.

Fiberglass and caulk/sealant insulate with a lower R/inch. May not be possible to caulk/seal all cracks and gaps.

Fiberglass is moisture permeable and may lead to condensation and subsequent mold, mildew and rotting.

Fiberglass is removable, allowing for simple visual termite inspection but it is important to re-install the batt insulation to RESNET Grade I standard or original condition.

A third method of insulating and air sealing of the framing near the foundation involves application of caulk or sealant around the perimeter of each cavity, followed by installation of insulation batts. Like the use of foam board insulation, it requires labor-intensive sealing. It should be noted that unlike SPF and boardstock, this is not a semi-permanent, long-lasting installation and may not provide desired levels of moisture condensation control. However, fiberglass batts can be removed for easier access to the band/rim joist and sill plate to facilitate termite inspection but must be carefully replaced to avoid compression (Table 1), and resulting substantial loss of energy performance.

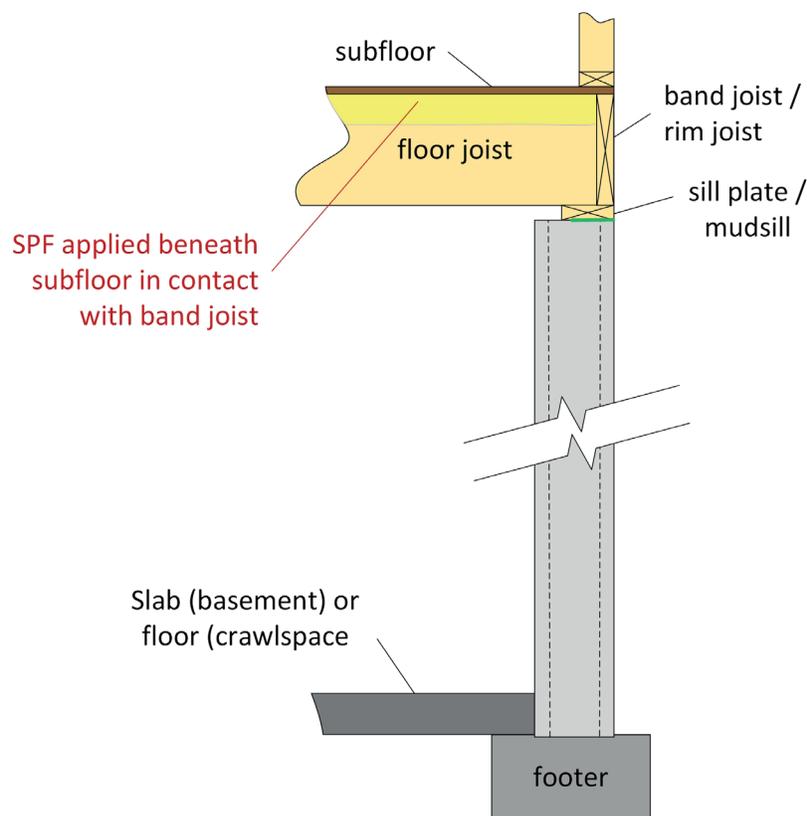
FIGURE 14. SPF Option F1 – Application of SPF Under Floor

For SPF insulation below floors, Figure 14 shows installation Option F1 of SPF beneath the entire subfloor, in contact with the top of the band/rim joist. This configuration allows for visual inspection of most of the band/rim joist and all of the sill plate. If the entire band/rim joist needs to be inspected, As with all the options presented in this document, readers may need to adapt their selected approach based on individual conditions and other specific circumstances.

Prior to installation of SPF insulation, SPF professional contractors should consult with the homeowner/customer to discuss which option in Figures 14 to 16 may be desired to avoid exceeding the capabilities of their chosen pest management company's inspection protocols, or warranty criteria.

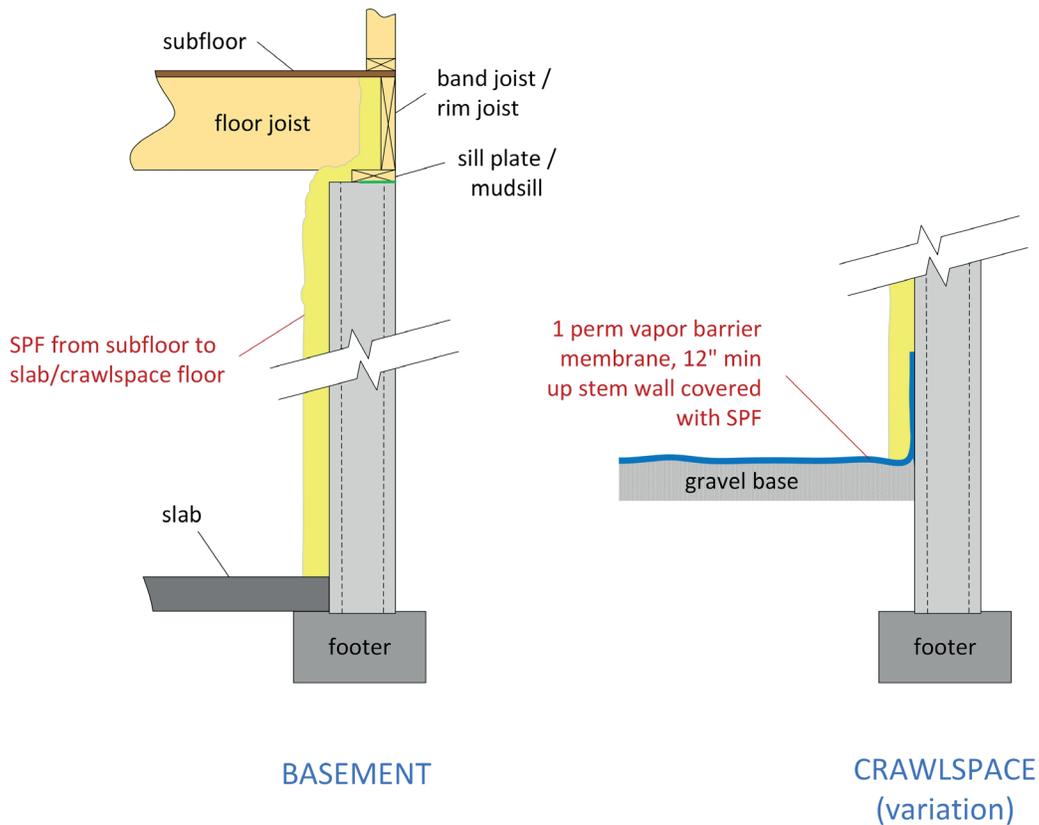
FIGURE 15. SPF Option W1 - Application of SPF Over Sill Plate and Band/Rim Joist

For SPF insulation of below-grade walls and the framing foundation interface, Figure 15 shows installation Option W1, where closed-cell SPF installed from the sub-floor to the basement/crawlspace floor. While this provides a highly effective solution for insulation and air sealing, it may impair simple visual inspections for termites.

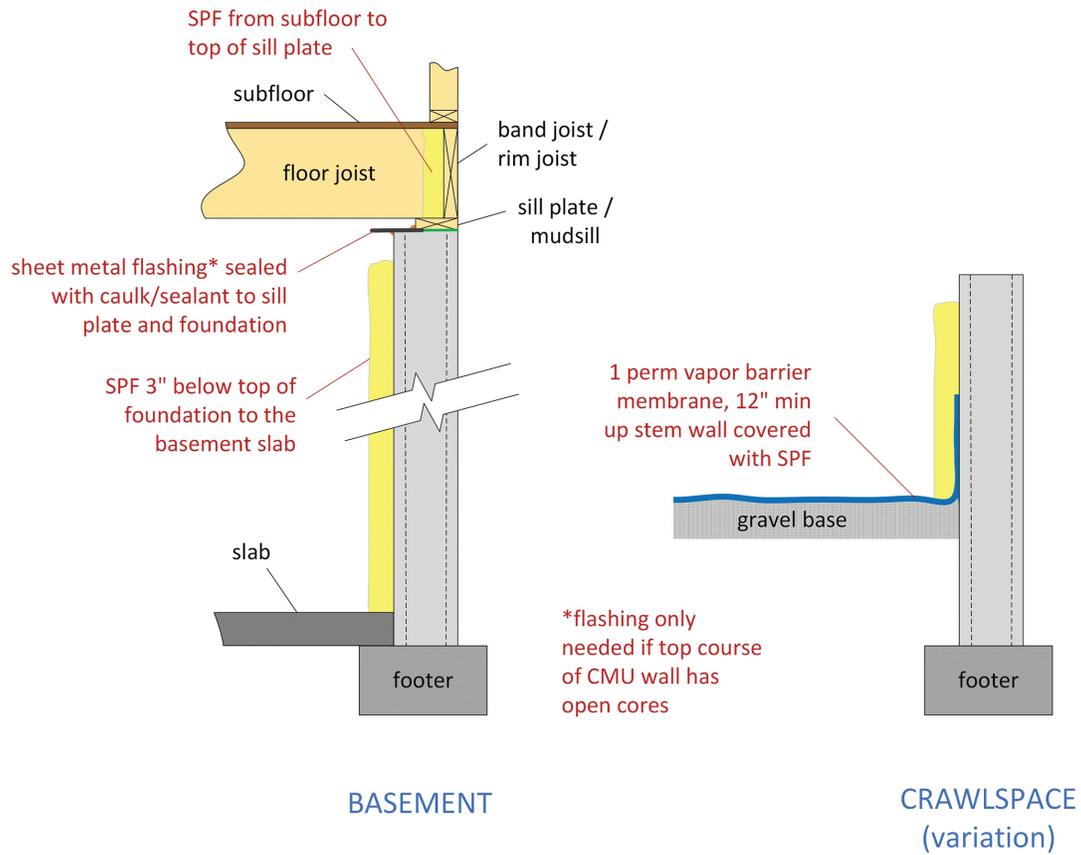
FIGURE 16. SPF Option W2 – Application of SPF Over Band/Rim Joist and Optional Sealed Flashing

Figure 16 shows installation Option W2, with inspection gaps at the top of the foundation, compliant with many state building codes. Option W2 will insulate and air seal the rim joist but leaves the front face of the sill plate exposed for improved visual inspection.

Note that W2 shows an optional installation of sheet metal flashing between the sill plate and foundation, with a bead of caulk or sealant between the sill plate and flashing to improve air tightness when the top course of the CMU block wall has open cores.
